# Surface modification of spring tine cultivator points with different metal powders by GTAW method

**ABSTRACT** The abrasive wear resistance of soil tillage tools is important for the agricultural equipment industry because abrasive wear caused by hard particles in the soil can shorten the lifespan of these parts. In this study, surface modification using FeCrC, FeTi, and Ni powders was carried out to improve the hardness and wear resistance of AISI 1040 material reversible spring tine cultivator points. The GTAW (Gas Tungsten Arc Welding) method was chosen for the energy input in the surface modification process due to its simplicity and efficiency. Microstructure studies were conducted using an optical microscope (OM), scanning electron microscope (SEM), energy-dispersive X-ray spectroscopy (EDS), and X-ray diffraction (XRD). Additionally, microhardness measurements and wear tests were performed. It was found that the hardness values for all three coating types were higher than the ones measured in the substrate material. The maximum microhardness was 726.1 HV0.2 for the coating with a 70FeCrC + 30FeTi composition ratio. As a result of the increased hardness in the coating laye

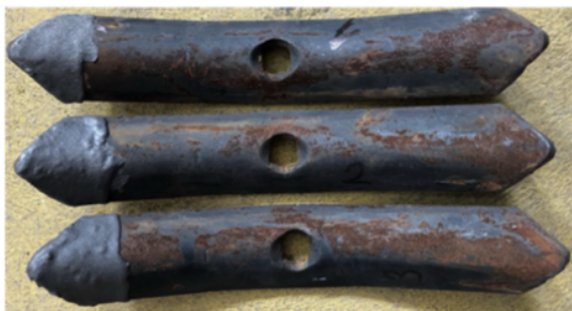
Figure 2: Dimensions of cultivator points.

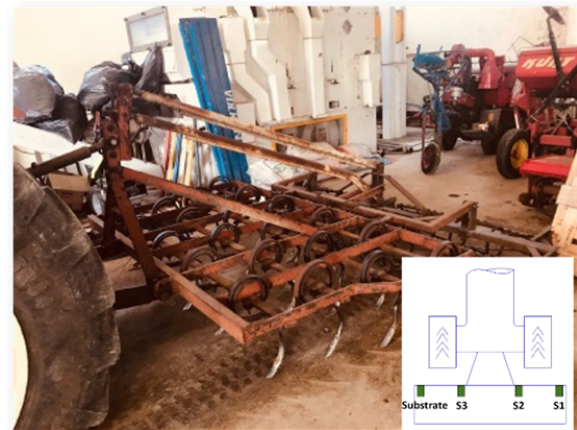
Figure 4: Spring cultivator used in studies and location of points.
